PHASE I ENVIRONMENTAL SITE ASSESSMENT

M & M ENVIRONMENTAL, INC.

**SUBJECT PROPERTY: 1650 MARINE VIEW DRIVE
TACOMA, WA 98422**

PROJECT NUMBER: 92SP1GLB

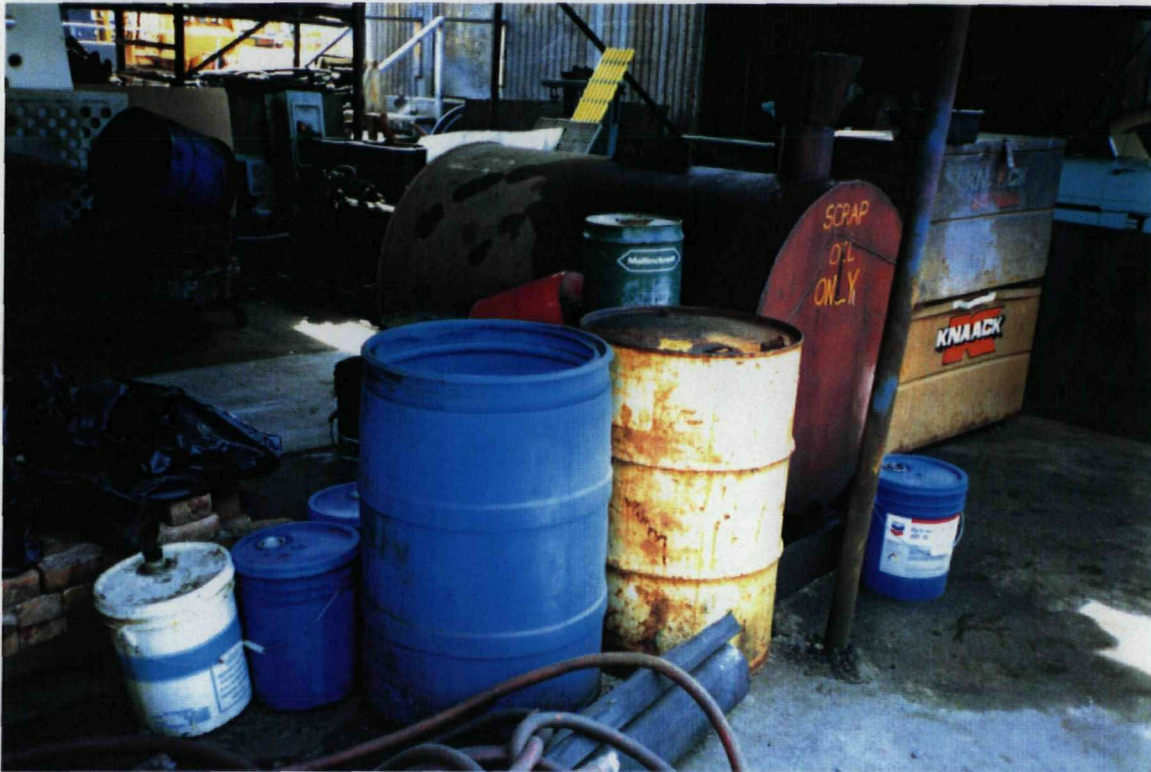
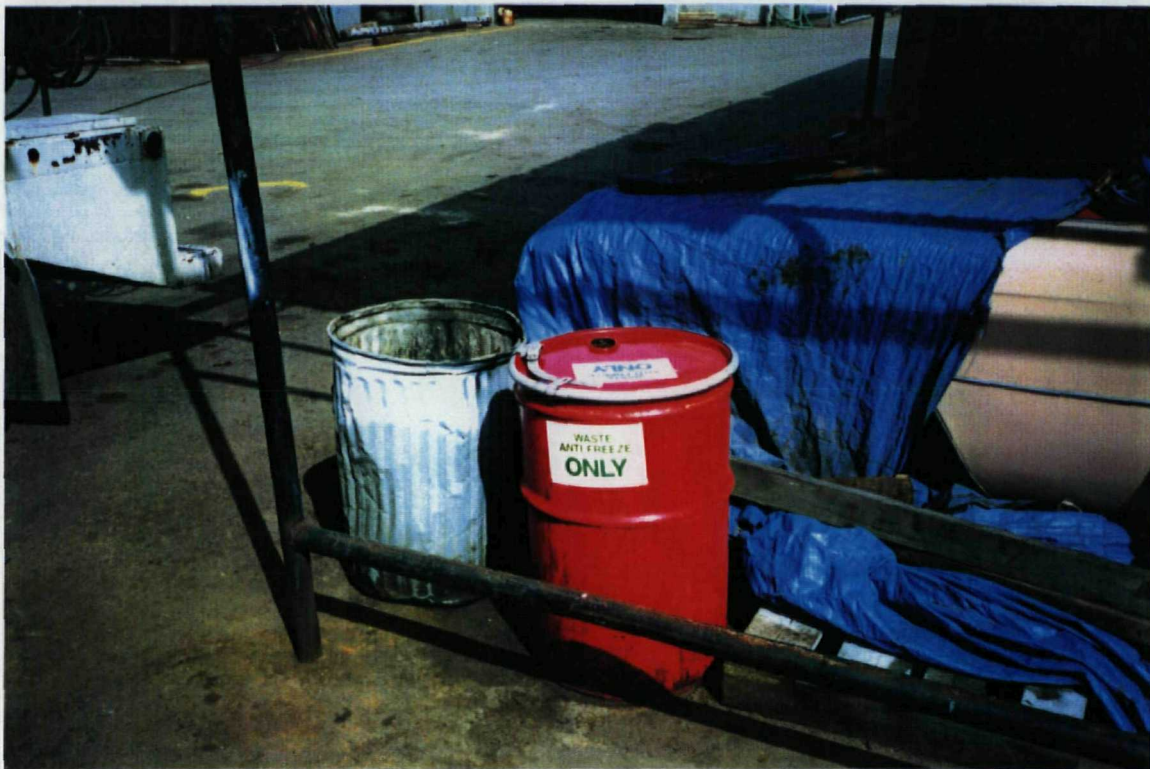
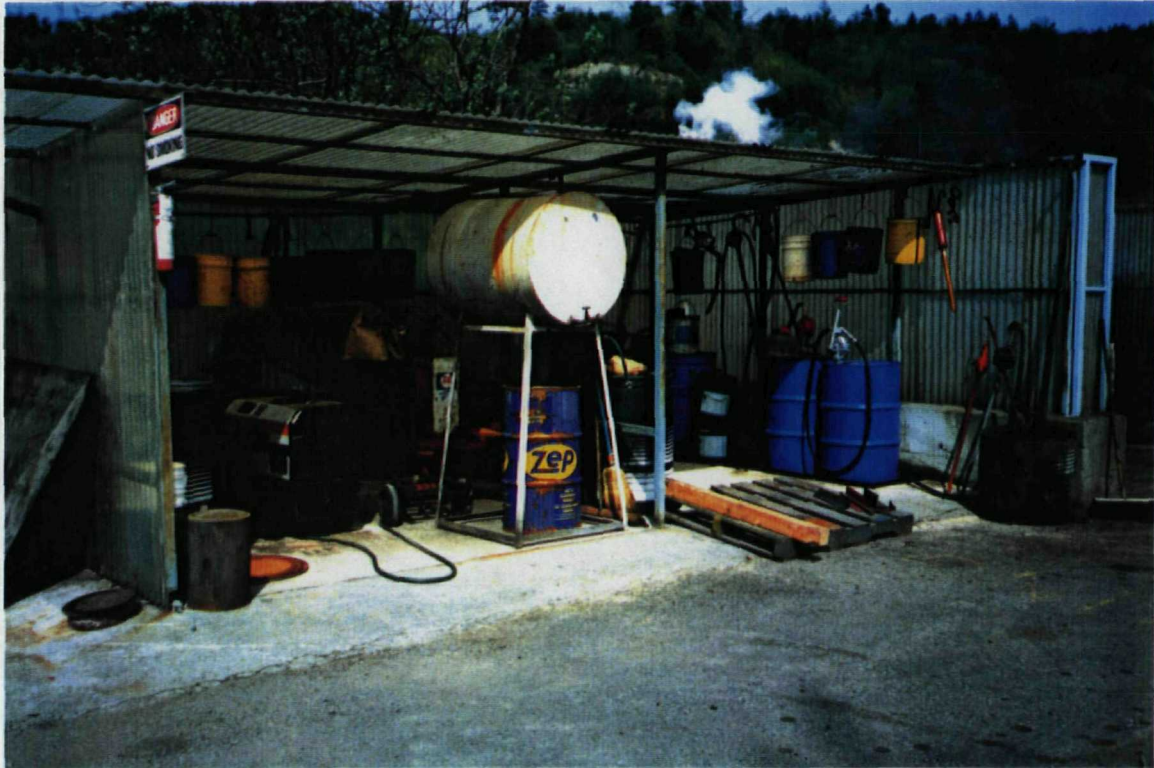
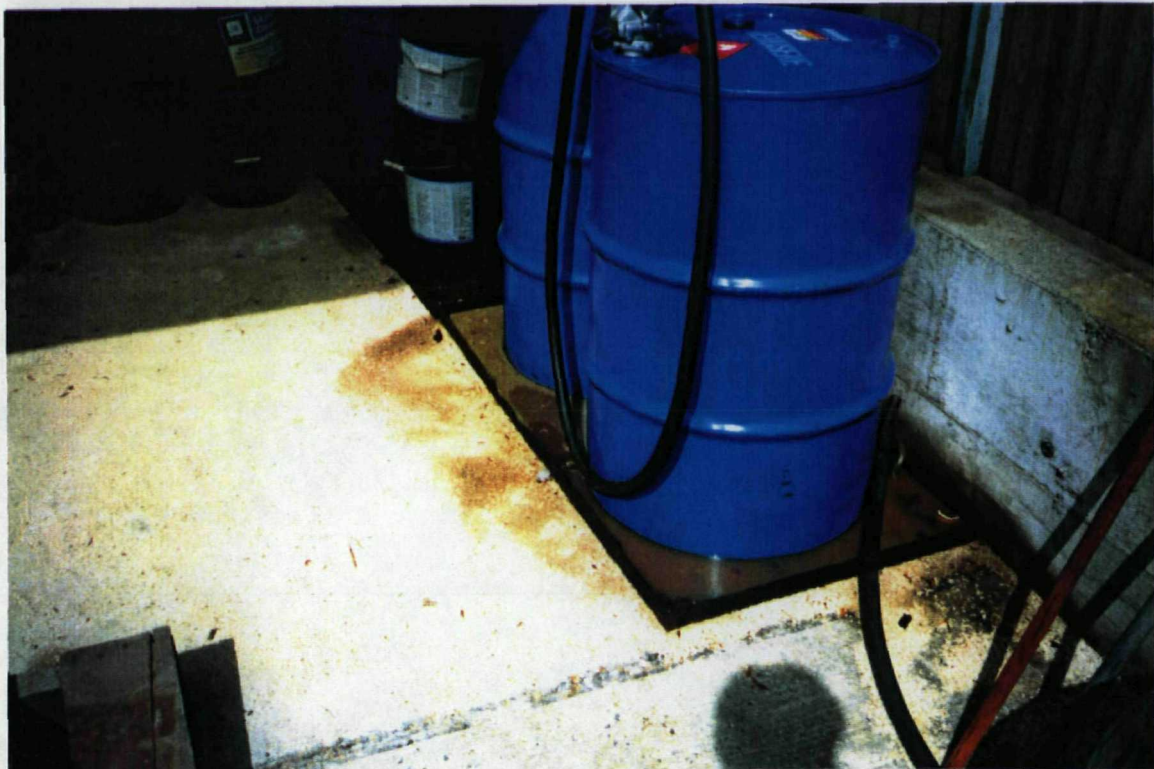
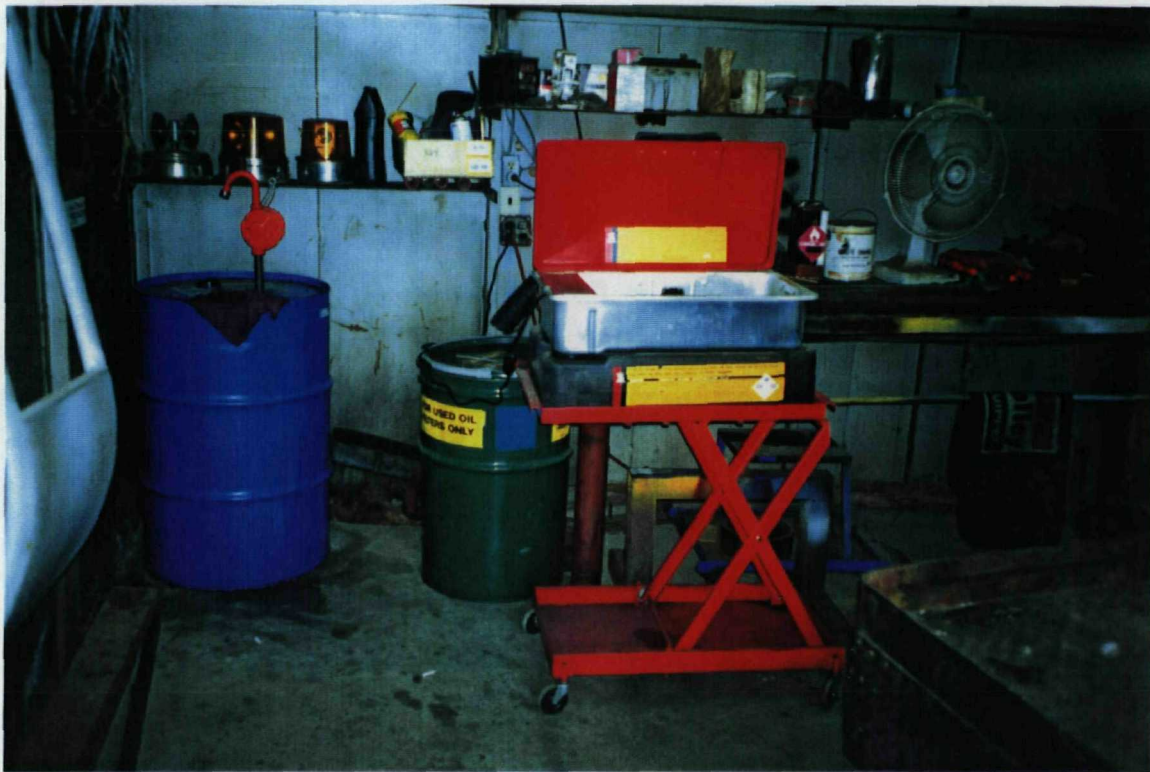
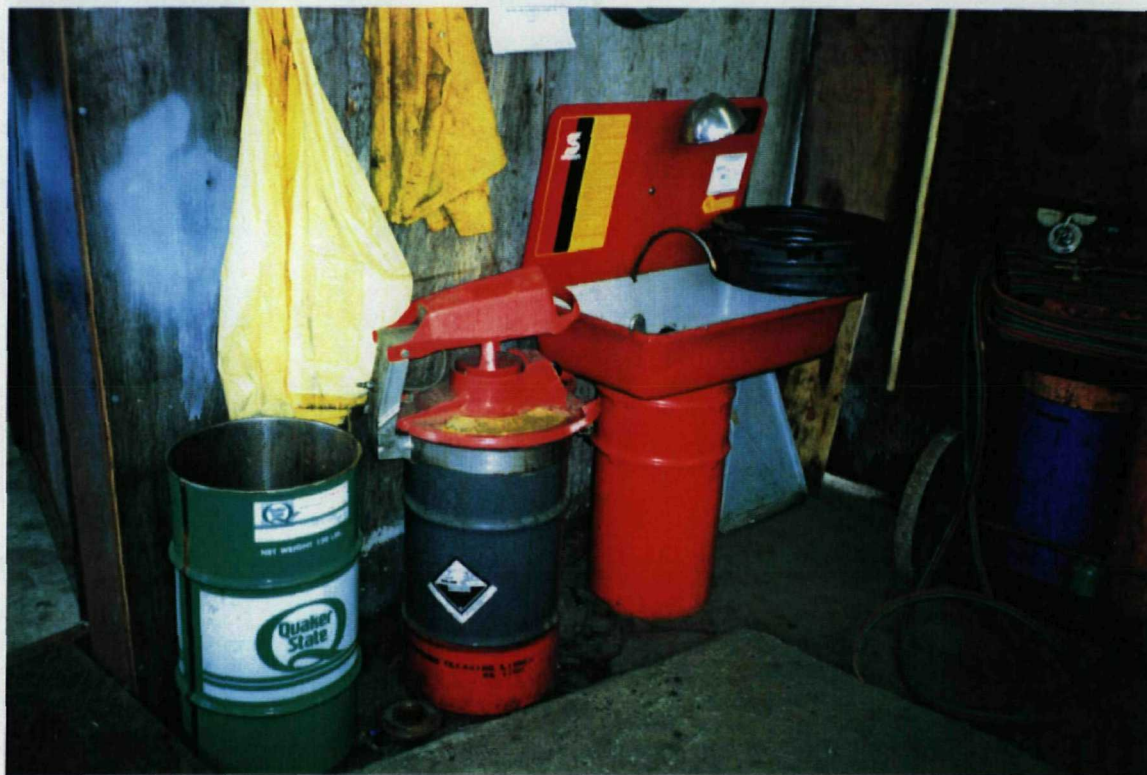
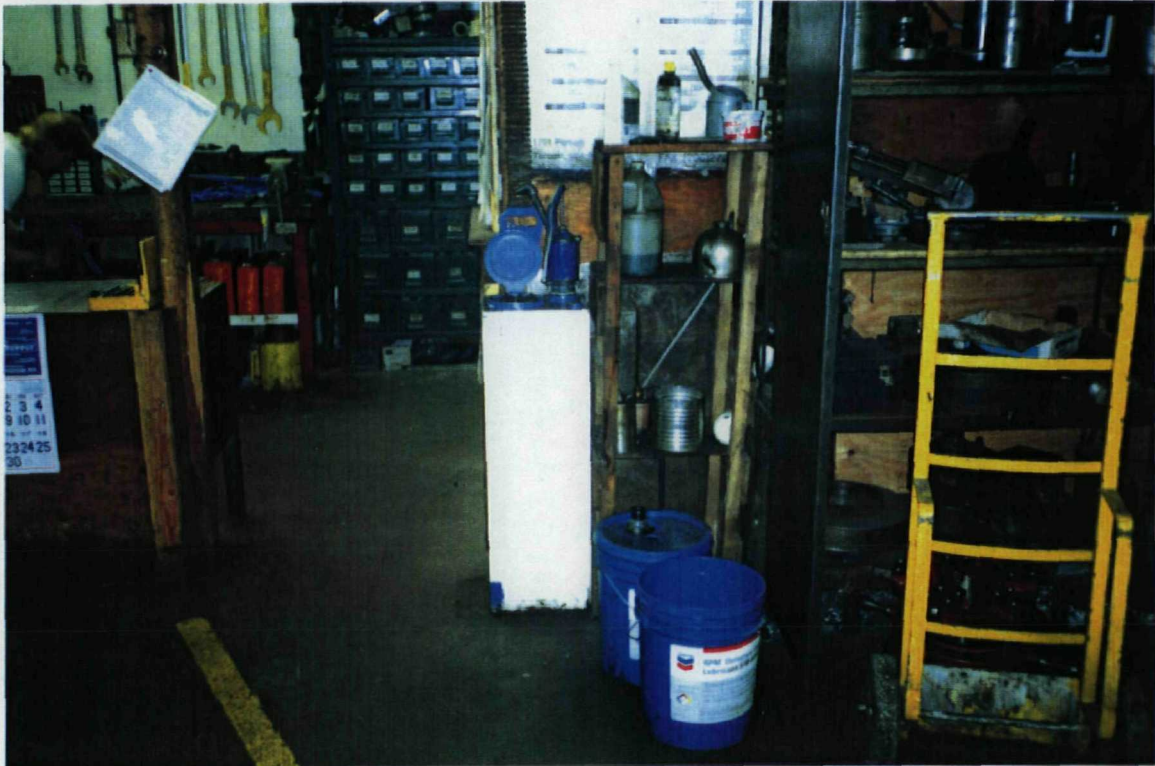
NEW/USED LIQUID STORAGE

NEW / USED LIQUID STORAGE

During the site reconnaissance of subject property, numerous containers of hazardous and/or toxic liquids in varying sizes, 5 through 55 gallons, were observed and predominantly were clearly identified and located under cover with few exceptions (see photographs). Waste antifreeze and a 55 gallon drum of flammable product were both observed near the paint storage building without impact or spill protection, as were a few oil and solvent containers located within the production areas. A curb that surrounds the materials, or secondary containment, will help prevent the materials from leaving the area should an accidental spill occur.

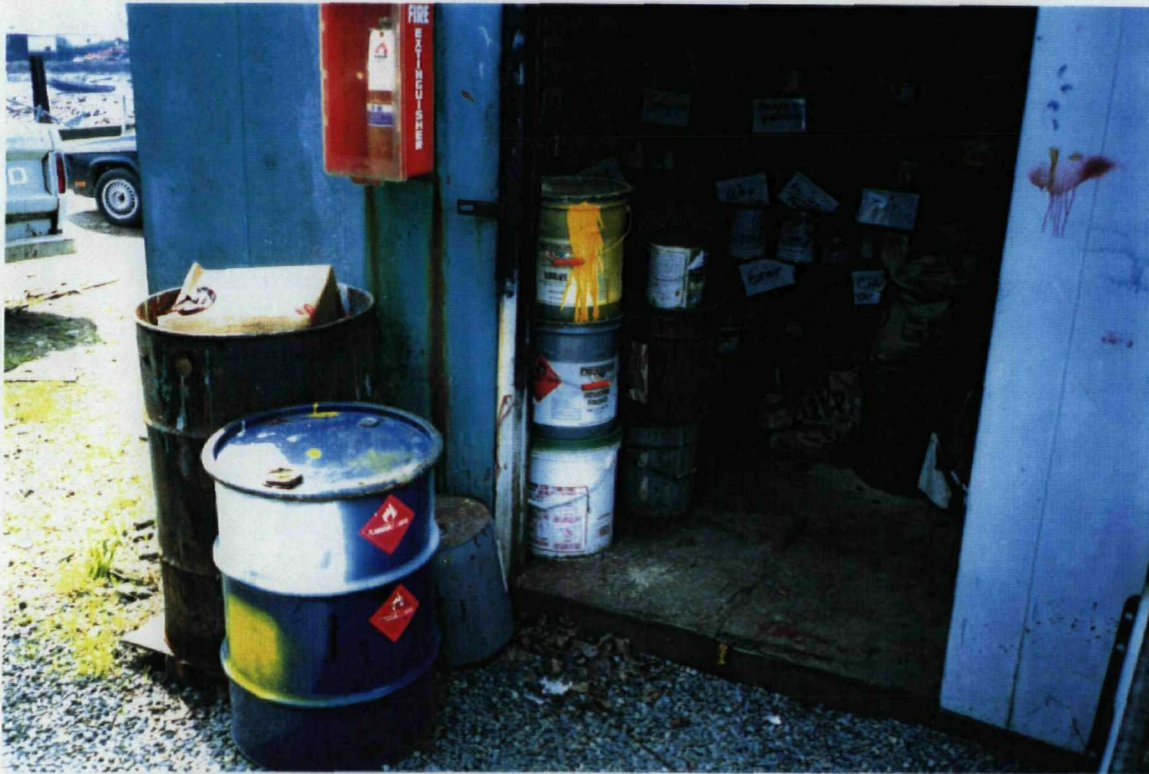
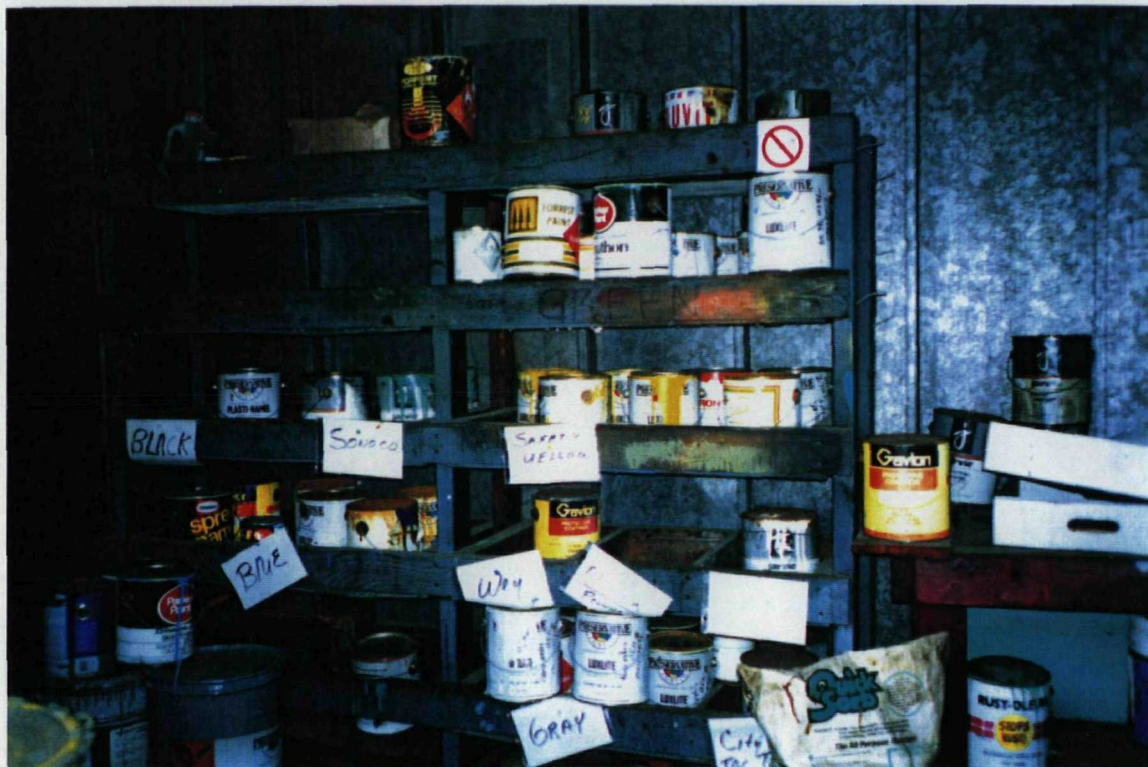
PAINT STORAGE

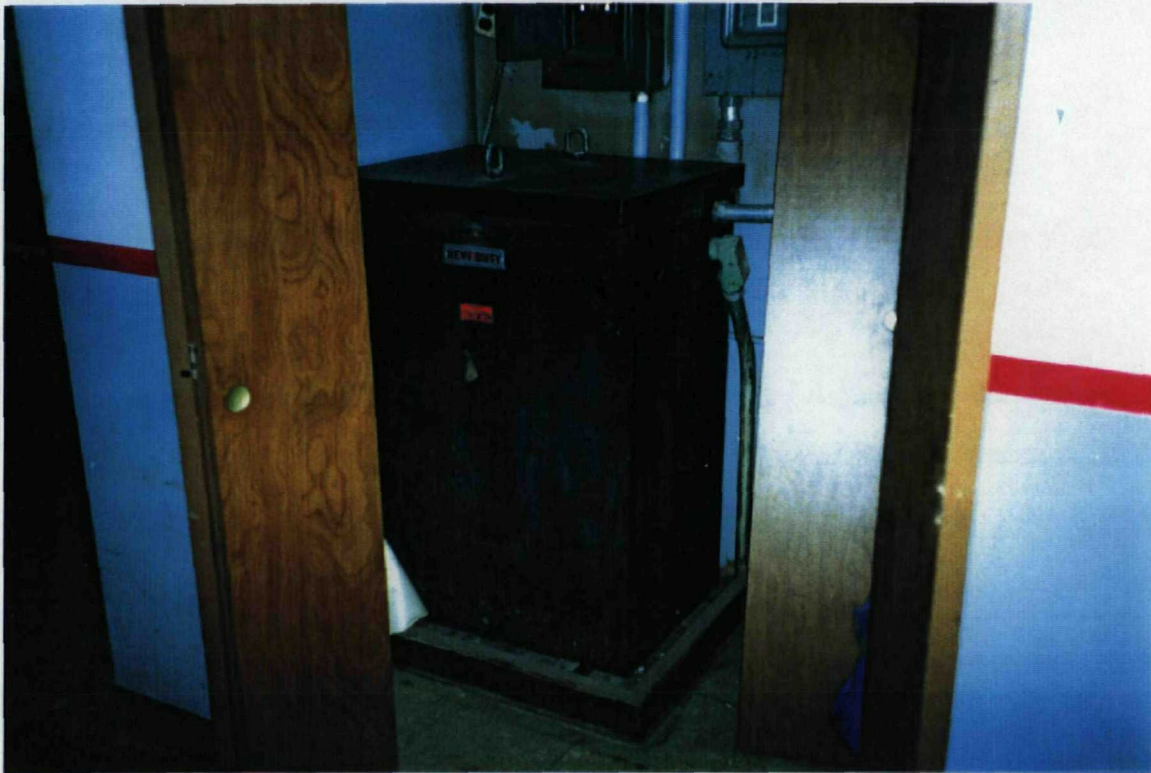
Located in the closet in the second floor ready room is an internal transformer manufactured by the Hevi Duty Electric Company: Type 321 #20736. The manufacturer was contacted regarding PCB content and confirmed that this transformer is a "dry-type" and is manufacturer certified to be non-PCB containing.

INTERNAL TRANSFORMER

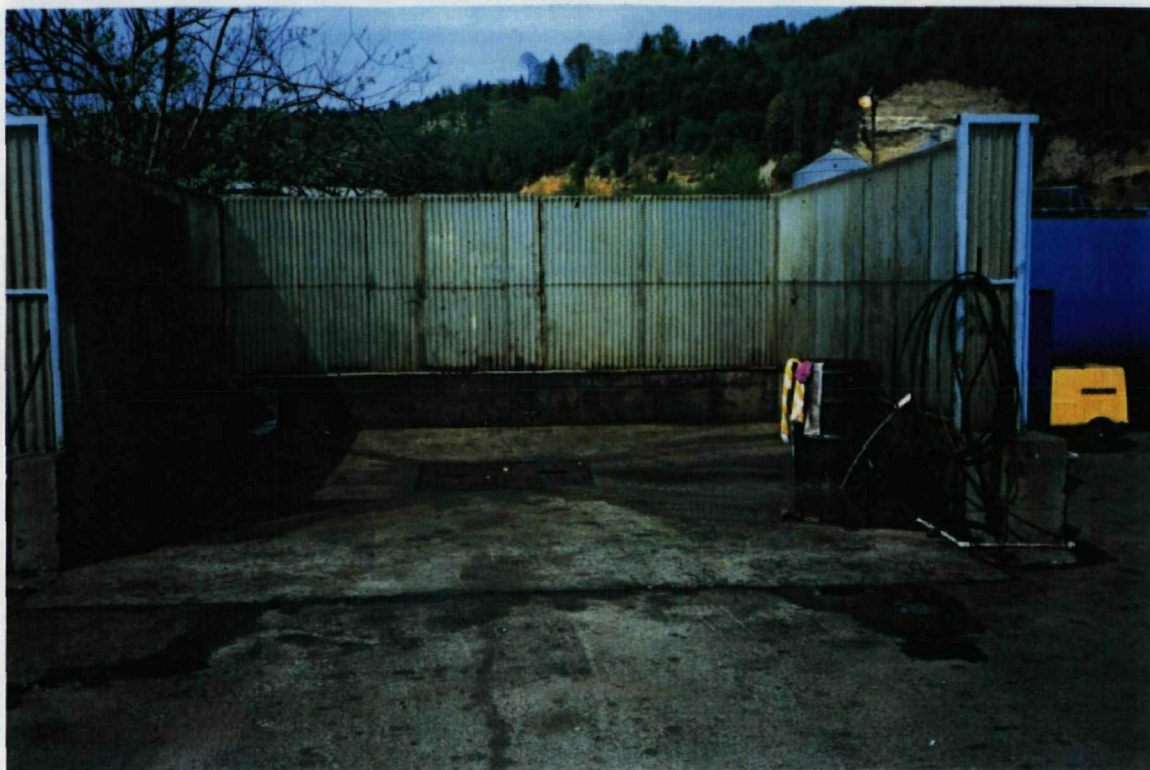
WASH RACK

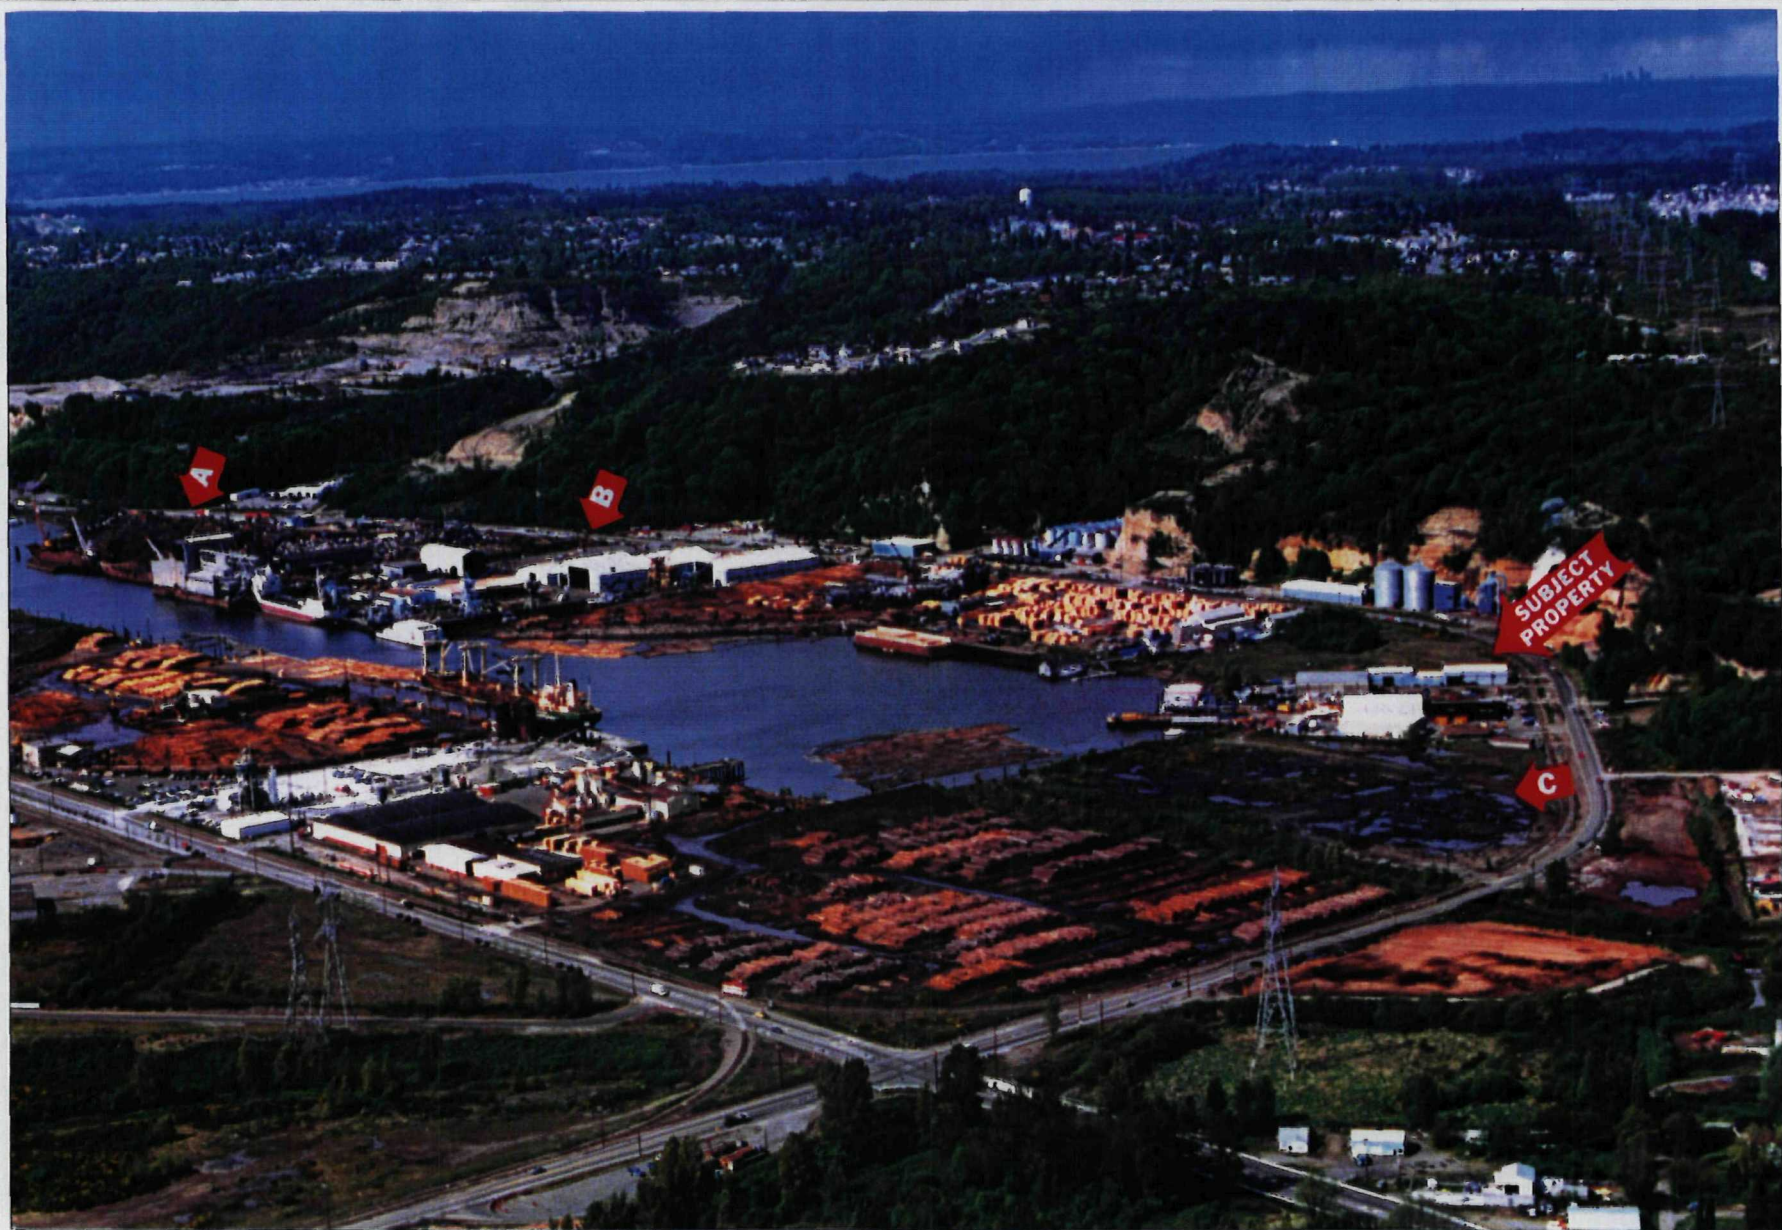
Additionally, as depicted in the Vicinity Reference Photograph, Site A (General Metals), and Site B (Tacoma Boatbuilding Company, Inc.) are sufficiently spaced from subject property that migration of the recorded contaminants is not likely and the contaminants recorded at Site C (Wasser Winters Log Sorting Yard) of heavy metals (lead, arsenic, copper and zinc) have low migration potential.
